Remote Vibration Analysis

Remote Analysis Capabilities

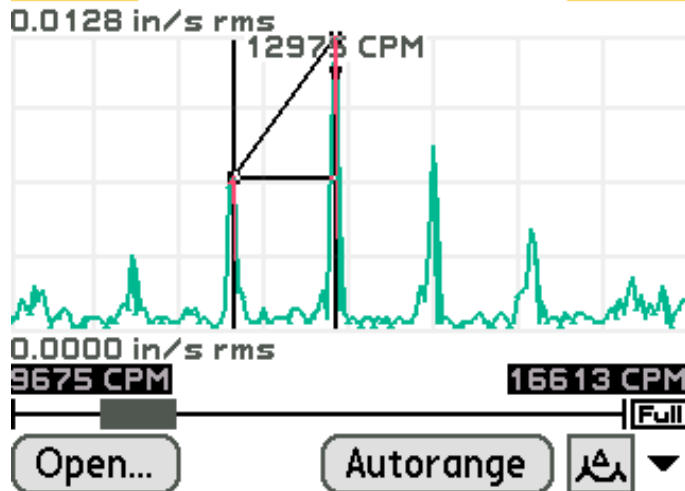
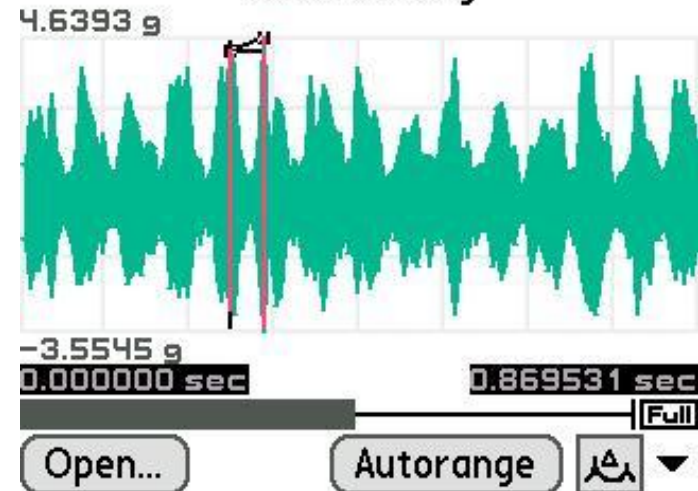
Actual Analysis From Treo

dx=-1013 CPM, dy=-0.0062 in/s rms
Breeza_Saber-lh_071231_124122

Overall: 0.0690 in/s rms

dx=-0.045703 sec, dy=-0.3904 g
Breeza_Saber-lh_071231_124208
RMS: 0.9460 g

Vibration Data at 12975CPM is the Inner Race Bearing Fault of the Lower Bearing. The Cursor in the spectrum shows the turning speed side banding present. Impacting of greater than 7Gs at this slow of a speed shows the issue is severe.

Replace the spindle bearings ASAP.

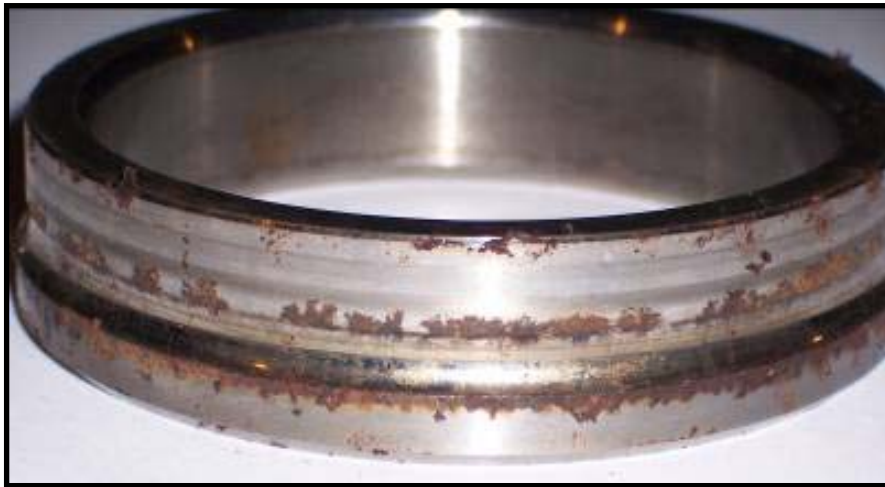
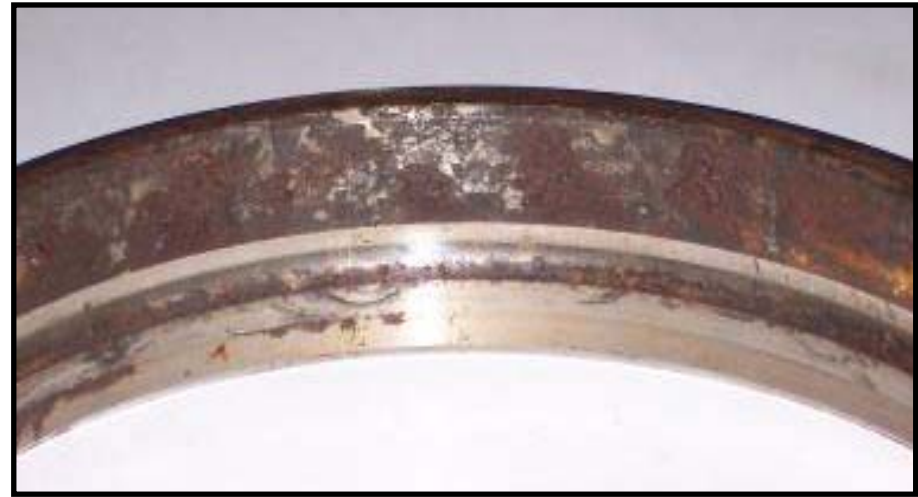
Bearing When Pulled

This is the condition of the spindle bearings after removing them. The coolant line had ruptured and purged all of the bearing grease out of the bearings. The coolant also continued running and caused the contamination and rust to develop.

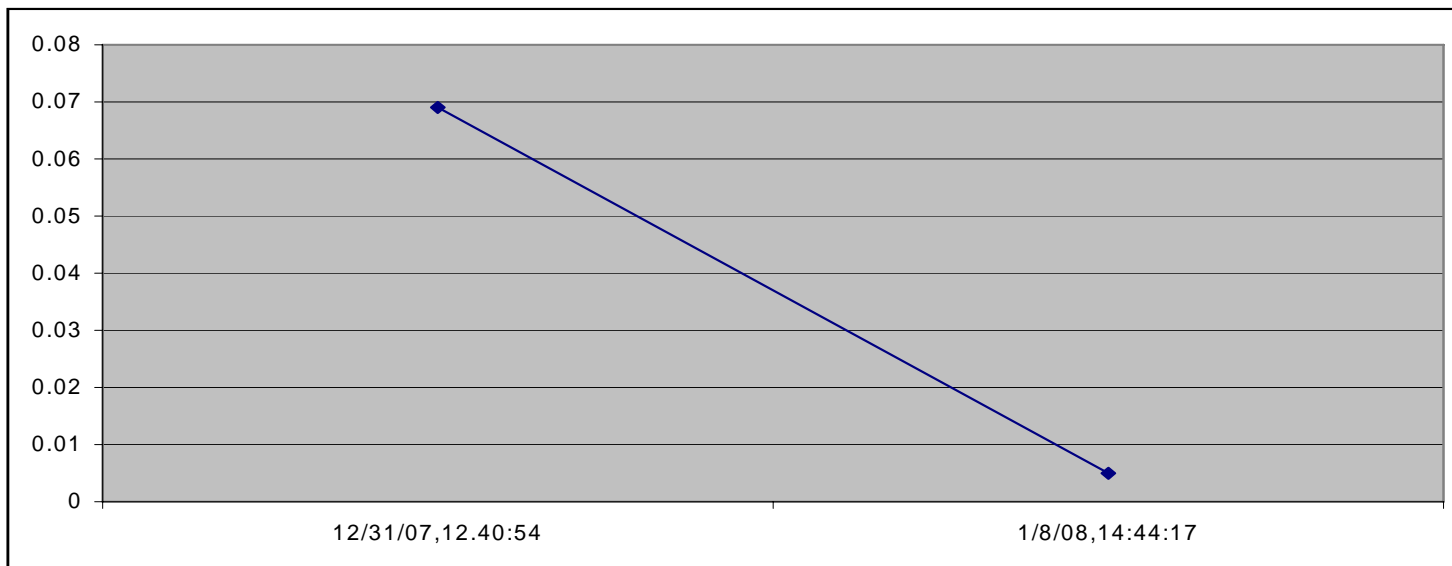
Vibration Data After Repair

<u>Date/Time</u>	<u>Value</u>	<u>Units</u>	<u>Severity</u>
12/31/07,12.40:54	0.06903	in/s rms	OK
1/8/08,14:44:17	0.004968	in/s rms	Normal

After the repairs there was a 92% decrease in the Overall Vibration Levels on the lower spindle bearing.
