# UTTER PRECISION, INC.

Subject: AHU-11 Air Handler Laser Sheave Alignment

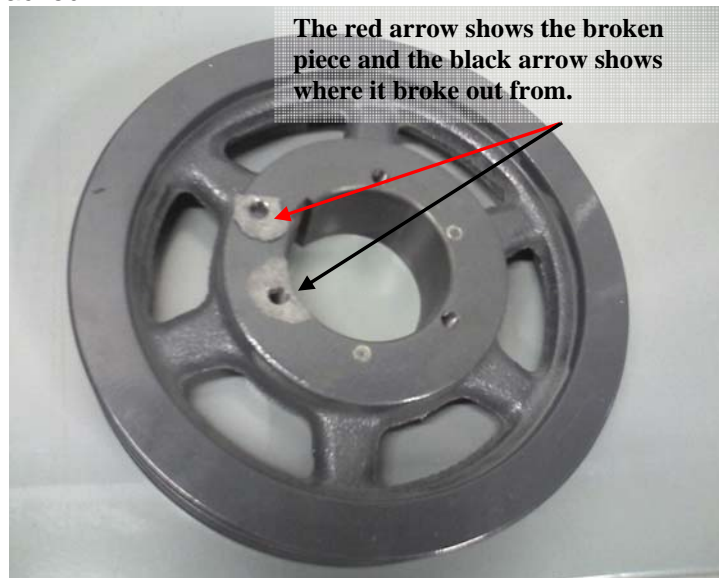
The sheaves had considerable offset misalignment. During the removal of the sheave hub to adjust the offset alignment, cracked and broken bolt holes were found. The picture below shows where the sheave bolt hole was cracked.

The new sheave was put on and found to have 5 mil axial run out issue. Discussions determined that this condition was acceptable for this machine.

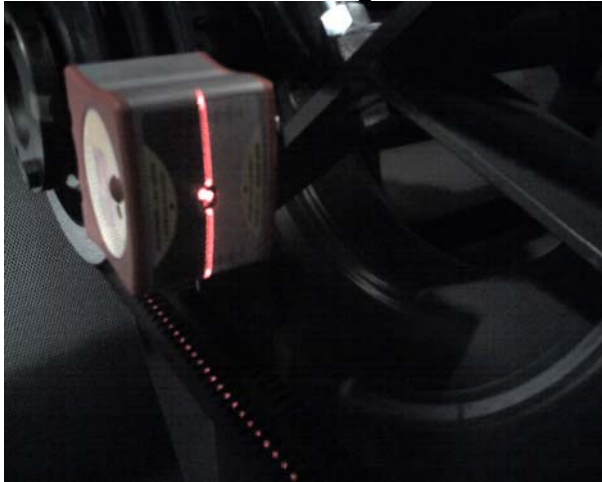
**Fan Sheave Alignment**

The alignment was completed and brought within the excellent range. The Belt Tension was set in accordance with the fan nameplate. Images on the next page show the alignment results.

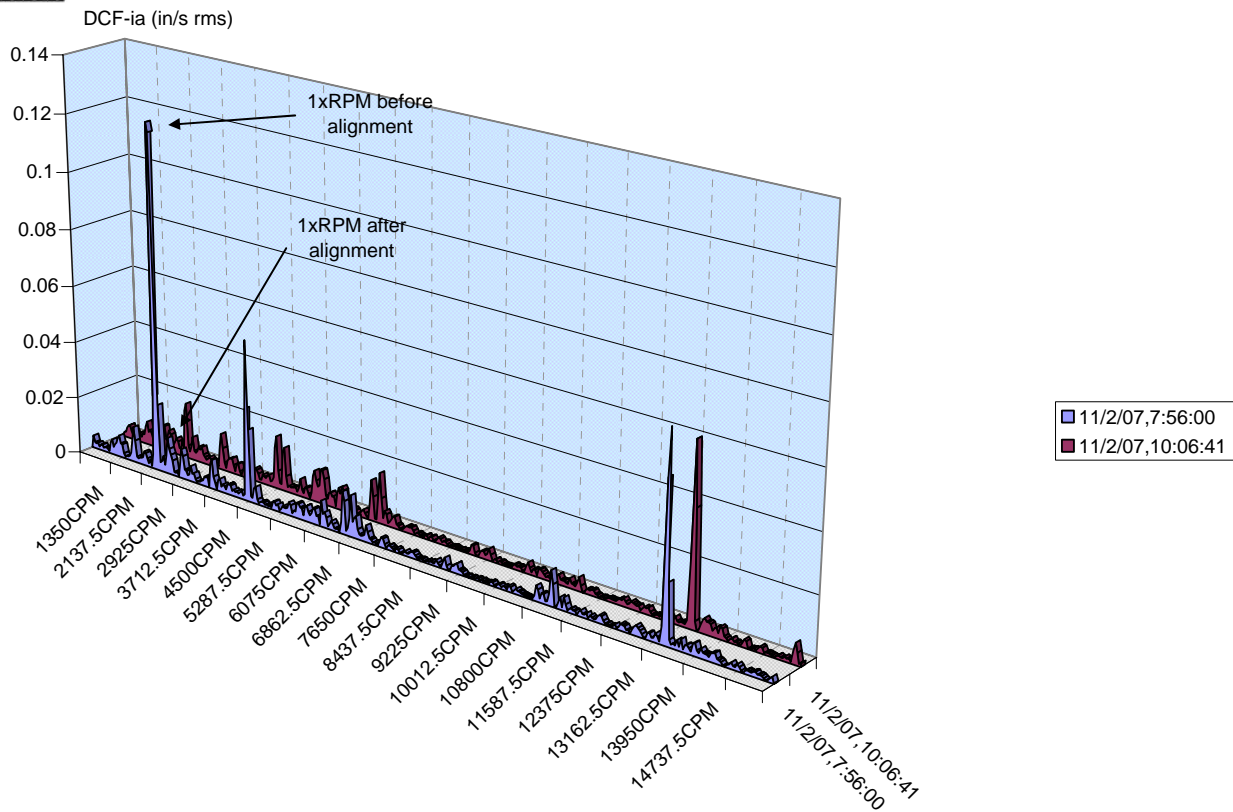
Waterfall Graph of Air Handler DCF-ia

vibration indicates **Short Term Use Allowable** use without damage to the bearings. Vibration taken after the alignment indicated the reduction of 43% in the vibration levels. This could not be reduced further due to the severity of the bearing condition.

Figure 1 shows the before and after misalignment found.

Generally it is recommended that bearing be changed when an alignment is performed so that the equipment is placed in the best condition possible. Due to the time limitation for the alignment, this could not be done so further monitoring should be done to determine the most advantageous time to replace the bearings.

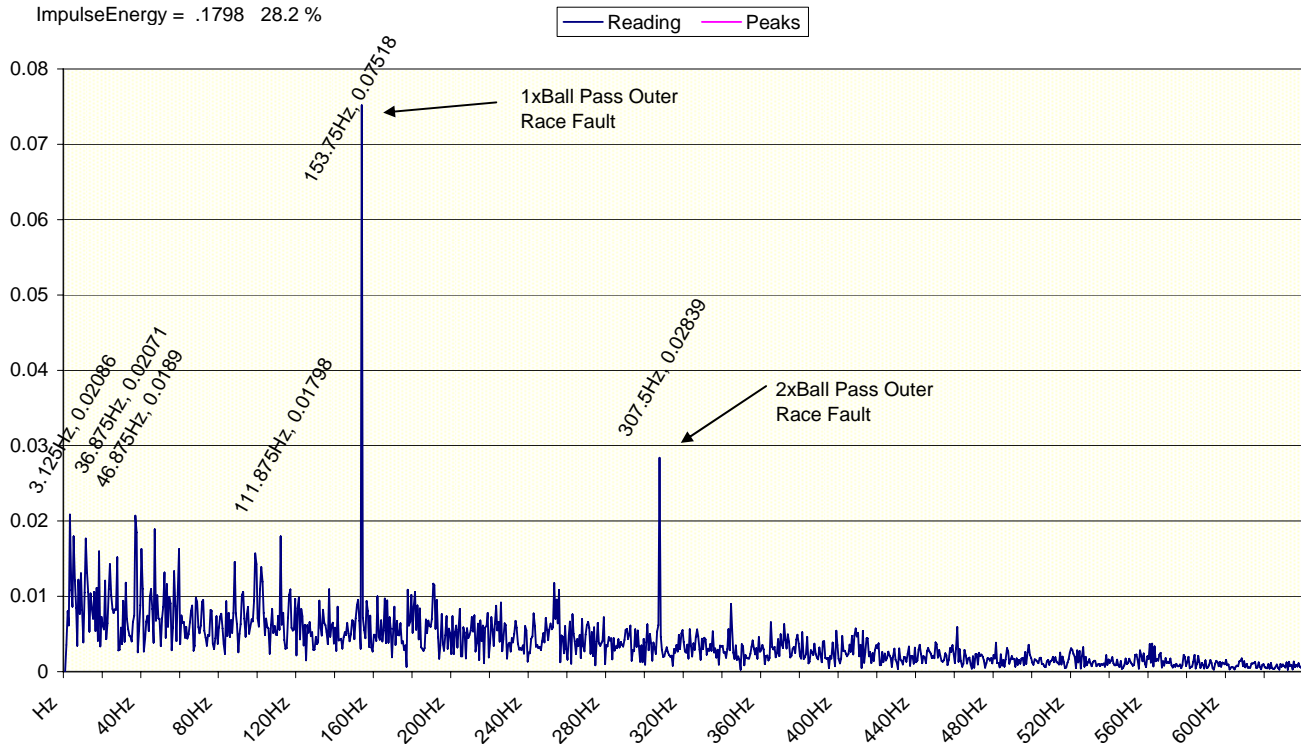
**Demodulation**  
**Air Handler**  
**DCF-ivwW 11/2/07,7:54:47**

Ultrasonic, vibration, and infrared readings were taken prior to and after completion of the alignment to check machine condition. Initial indications of ticking noise on the drive end fan bearing. Ultrasonic and vibration analysis confirmed bearing wear. The unit was also checked for severity of heating with infrared and the overall condition of the machine with vibration.

Figure 2 shows the bearing faults present.

ImpulseEnergy = .1798 28.2 %
