UTTER PRECISION, INC.

Building Infrared Report

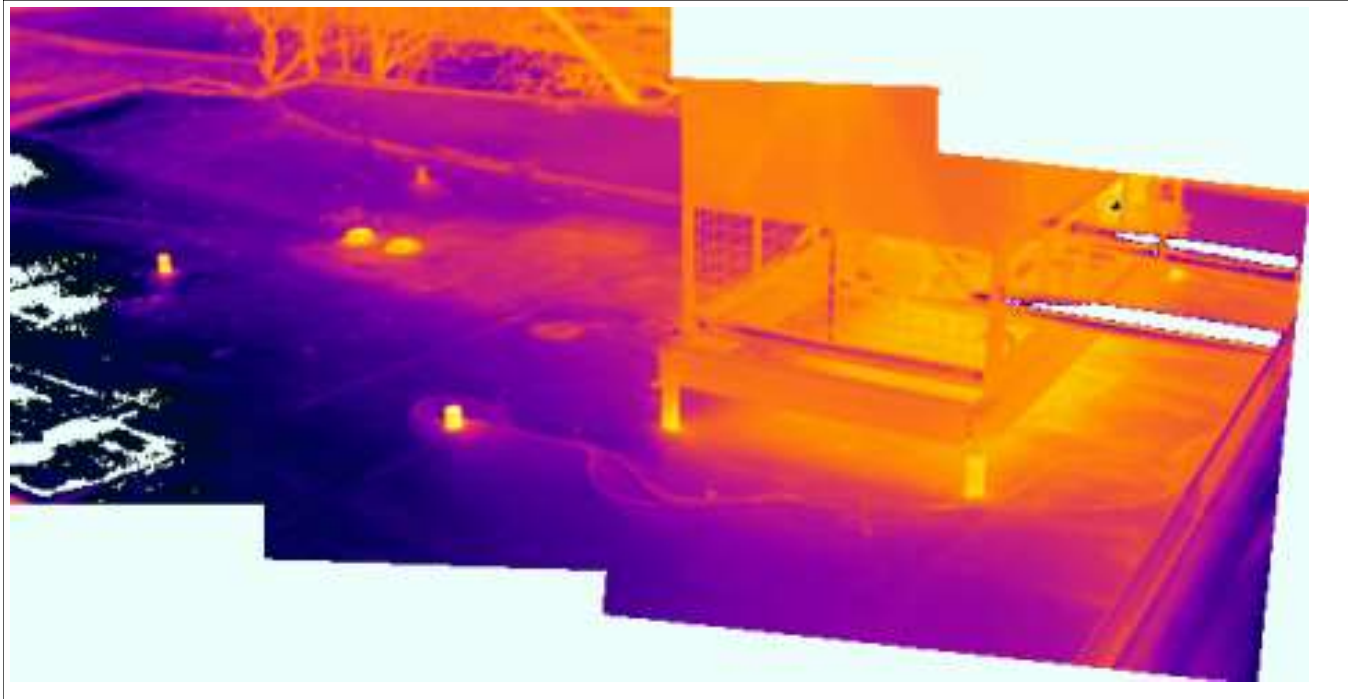
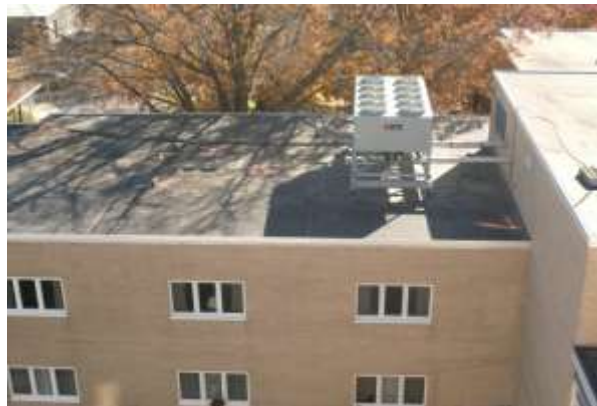
Area: East side under HVAC Unit / Area #15

Priority: High Concern

Concern: Suspect Moisture Infiltration

The entire area under the HVAC Unit and going out to the drains is of high concern for moisture infiltration. The area behind the conduit shows areas of suspect moisture intrusion and substrate damage.

Core Samples should be taken to confirm the presence of moisture.

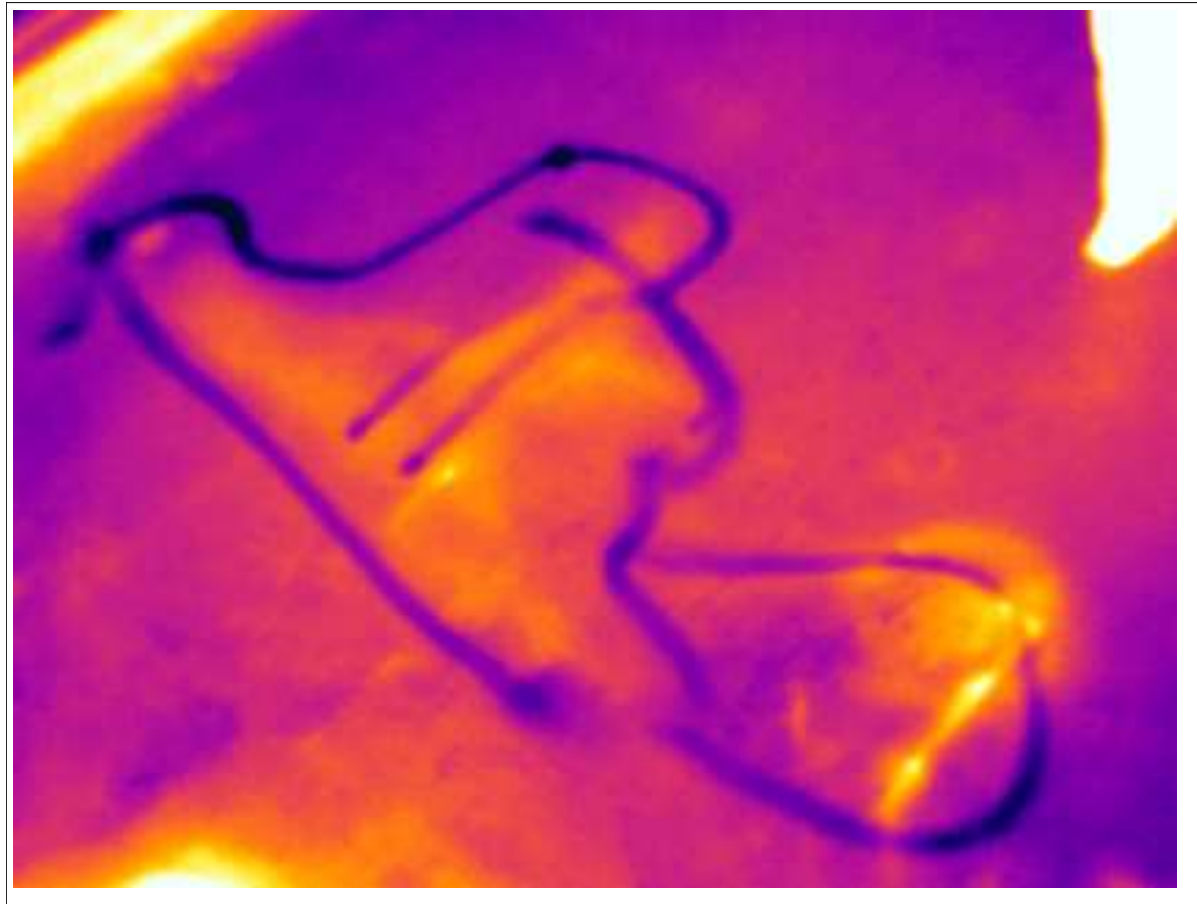
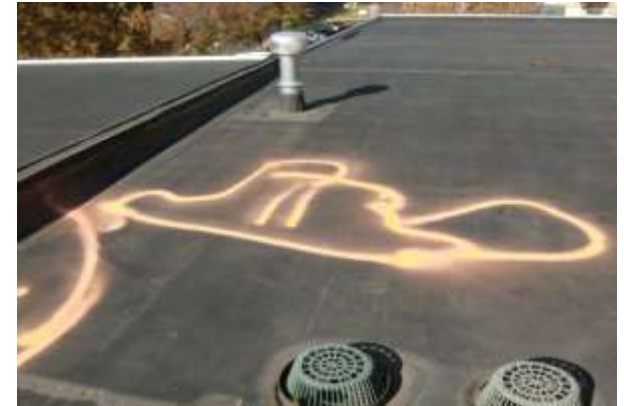
Area: West side of Building Area #11

Priority: High Level Concern

Concern: Suspect Moisture Infiltration

Area #11 shows the outlining of lapboard as a result of suspect moisture infiltration separation.

Core Samples should be taken to confirm the presence of moisture.

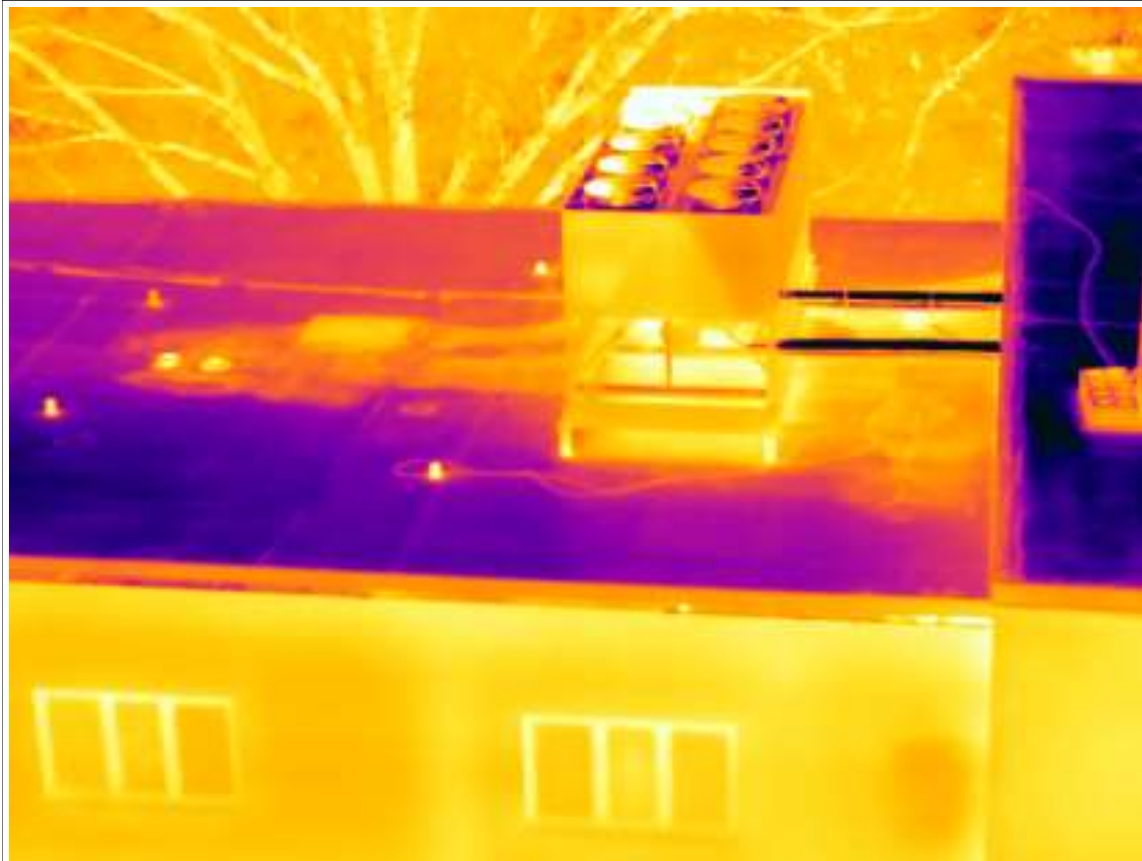
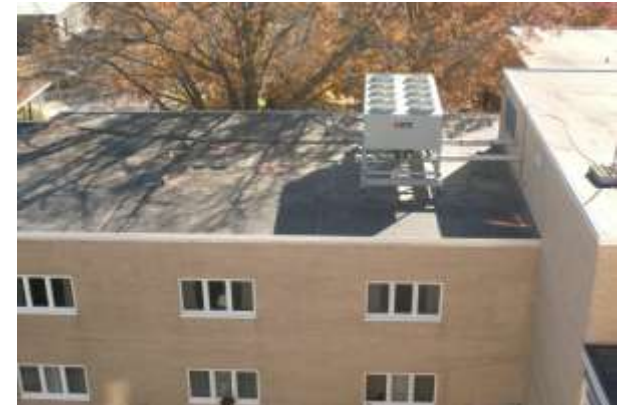
Area: East Area Looking from Main Building

Concern: Concentrated Area of Moisture Infiltration

This image was taken early in the late afternoon and shows the severity of the water infiltration in the area under the HVAC back to the wall and out east to the drains.

Core Samples should be taken to confirm the presence of moisture.

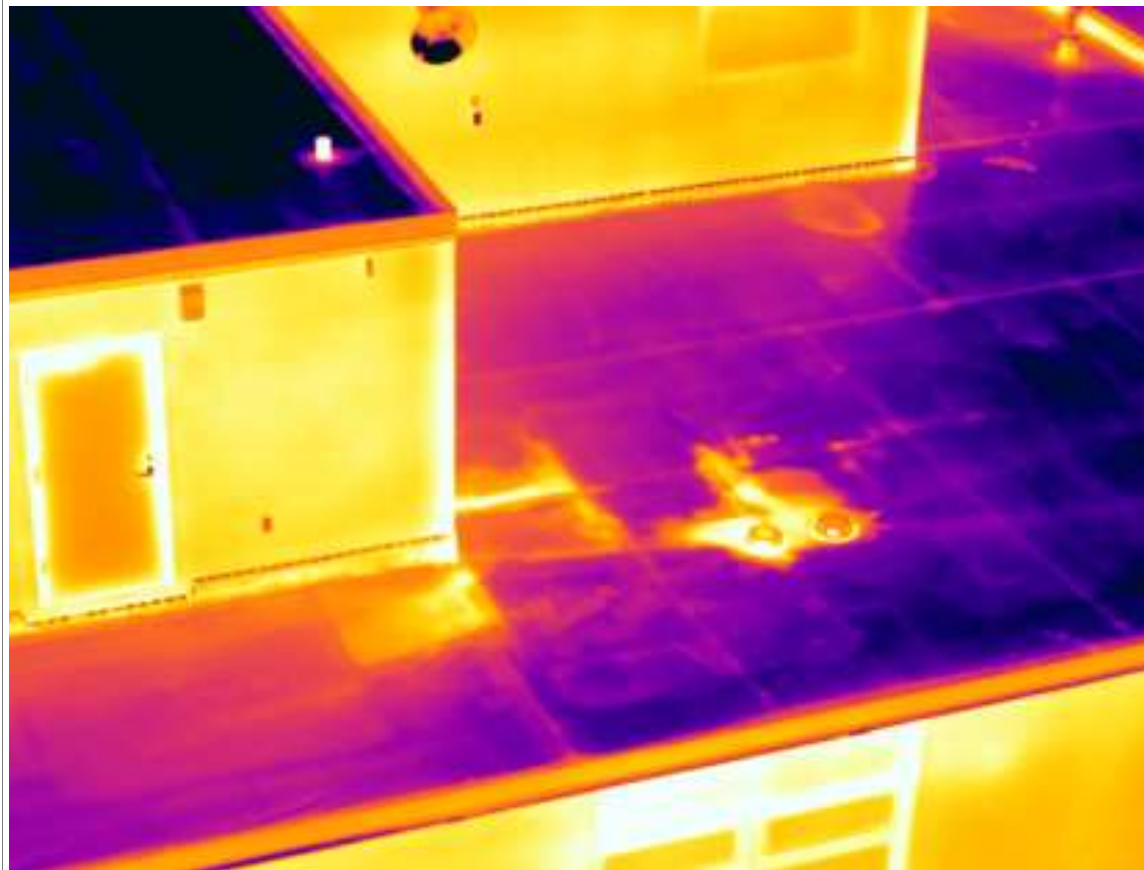
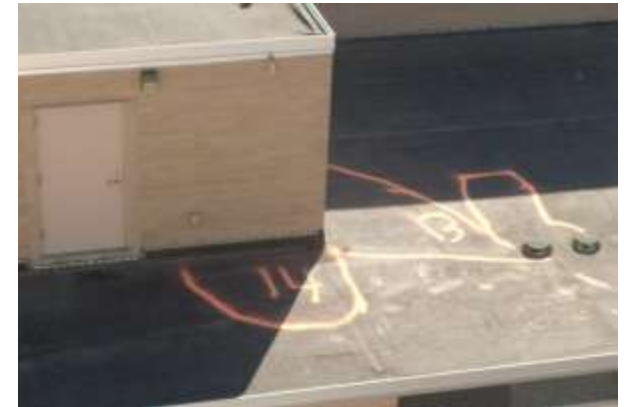
Area: North Central Area looking from Main Building

Concern: High Levels of Moisture Infiltration

This image was taken early in the late afternoon and shows the severity of the water infiltration around the drains and next to the wall on the west and north sides.

Core Samples should be taken to confirm the presence of moisture.

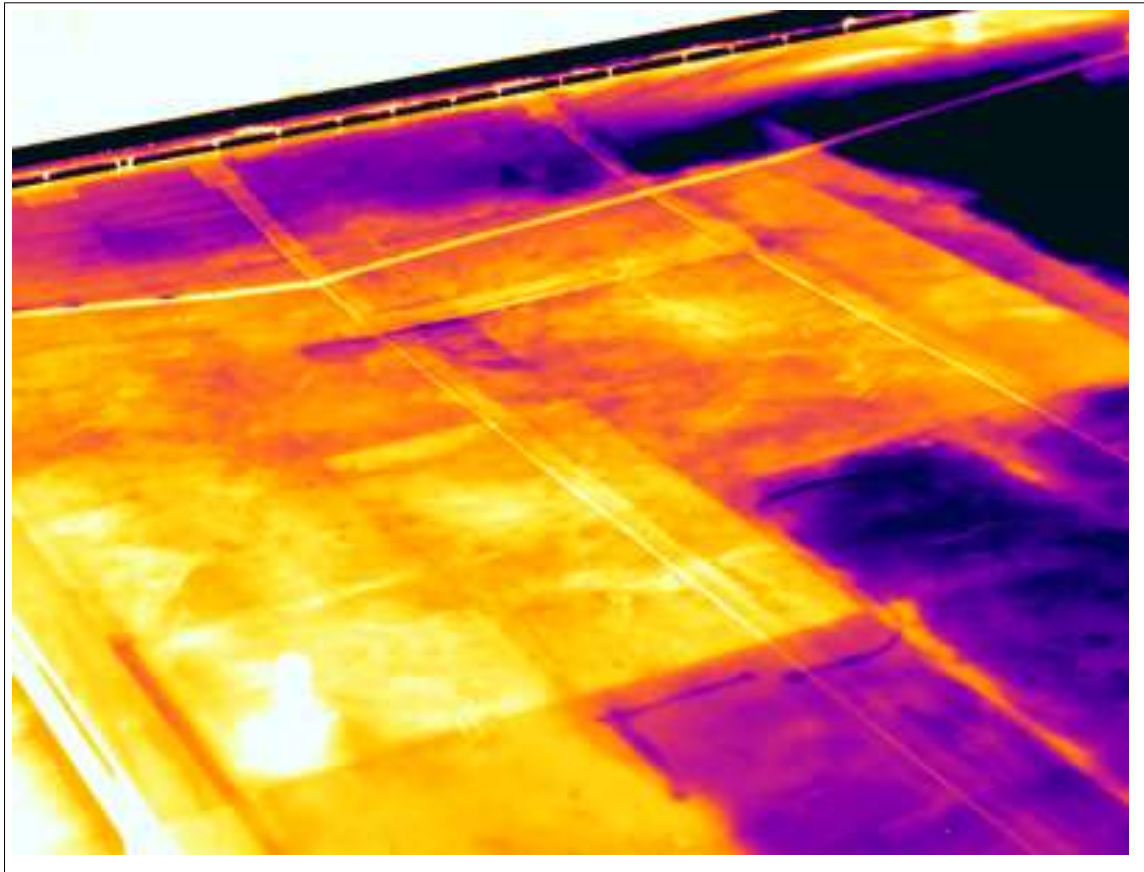
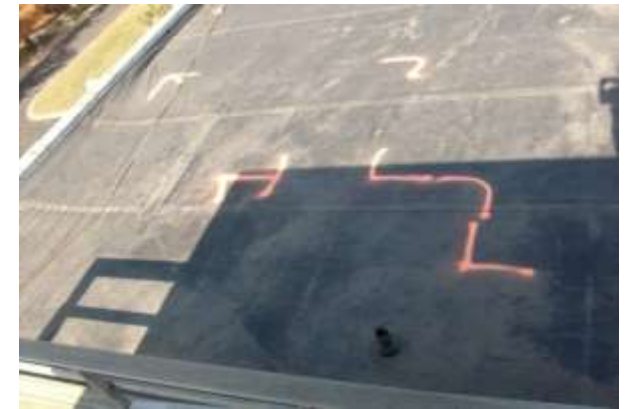
Area: North of Penthouse / Area #1

Priority: High Level Concern

Concern: Suspect Moisture Infiltration

This image was taken early in the late afternoon and shows the severity of the water infiltration throughout the large area north of the penthouse. The main area of concern is approximately 21ft x 33ft. The North section overview on page 26 shows the entire layout of where the suspect moisture infiltration of Area #1 is. Core Samples should be taken to confirm the presence of moisture.

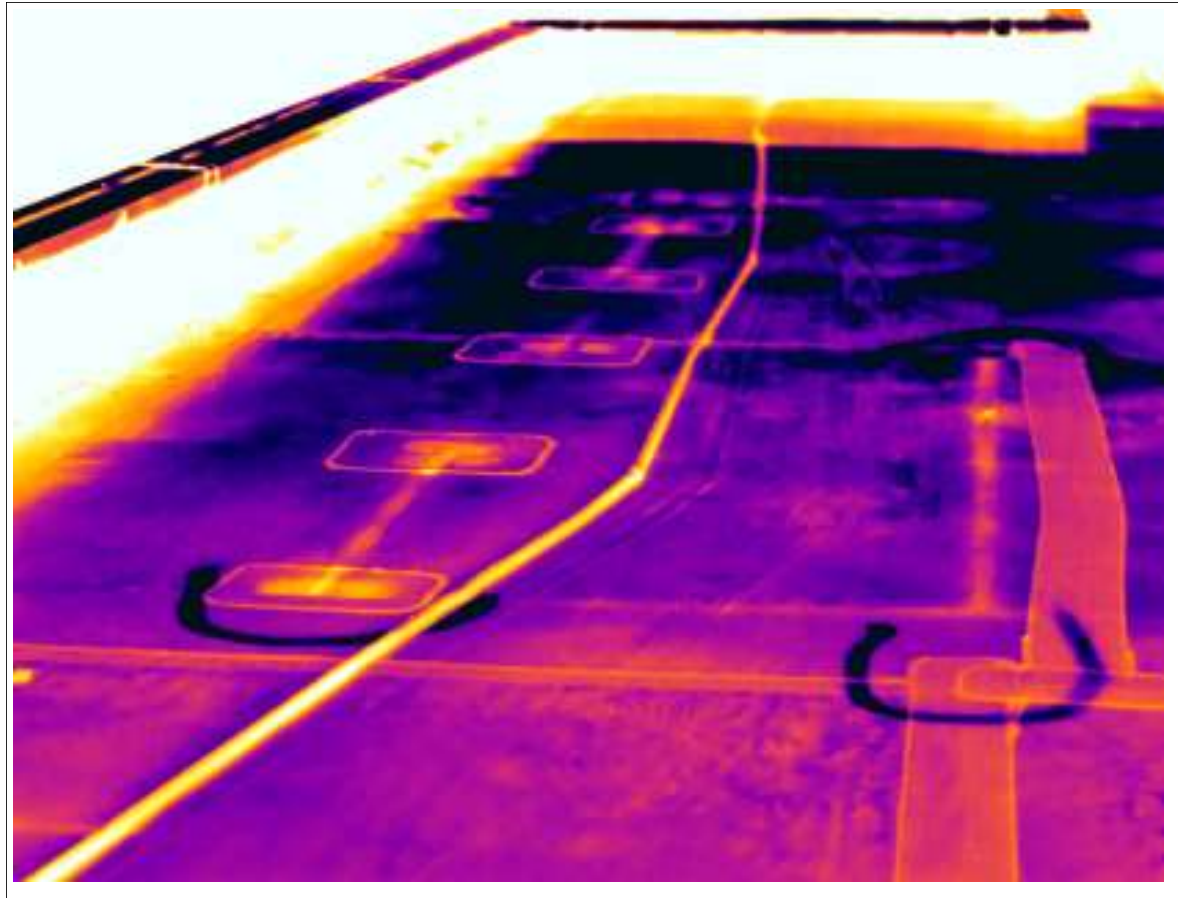
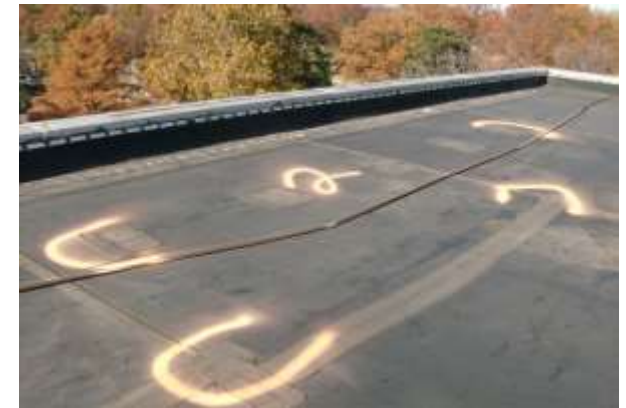
Area: Northwest Side / Area #2

Priority: High Level Concern

Concern: Suspect Substrate Separation

Area #2 shows mainly the outline of the lapboard between the repair areas. The result of suspect lapboard separation due to moisture damage. Core samples should be taken to confirm the presence of moisture.

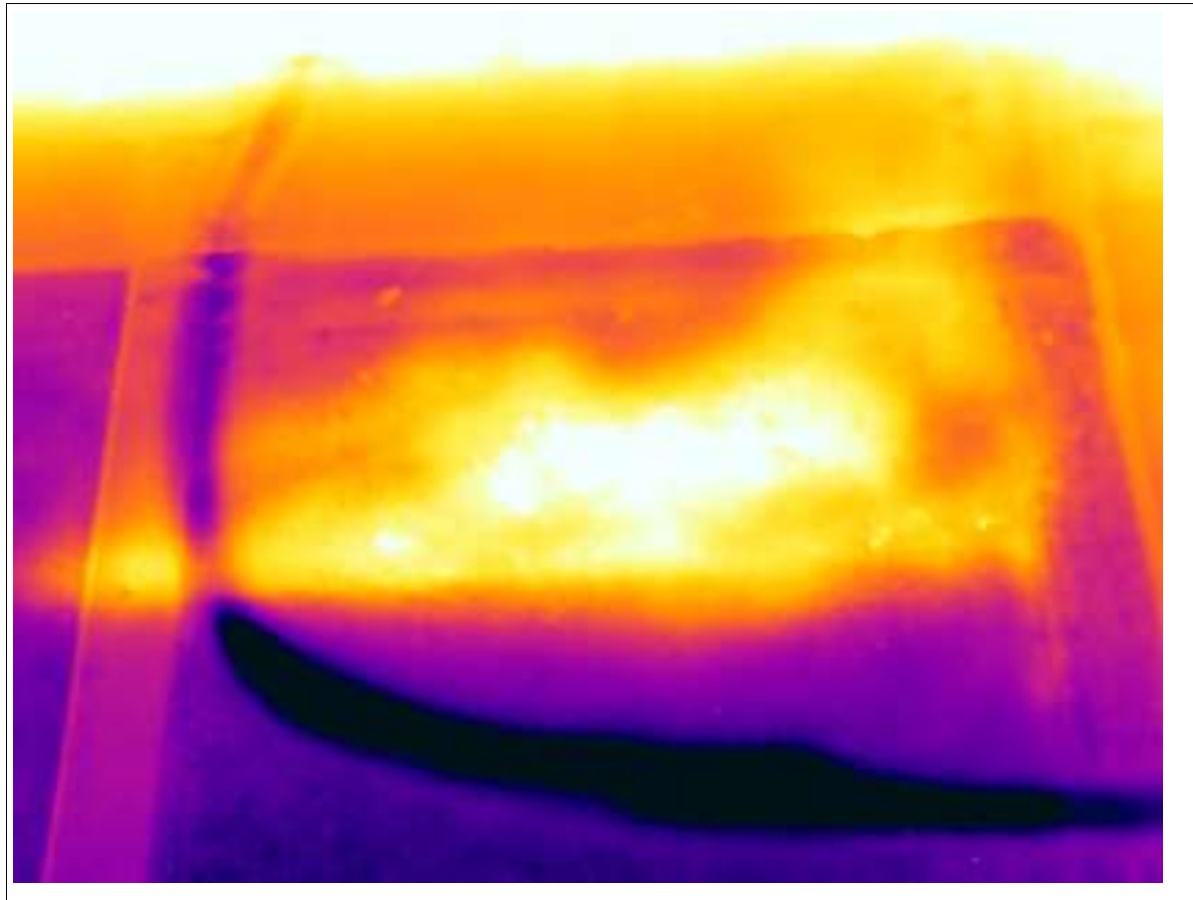
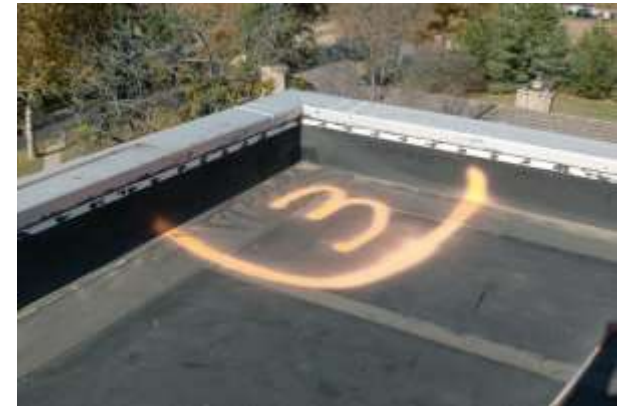
Area: Northwest Corner / Area #3

Priority: High Level Concern

Concern: Suspect Moisture Infiltration

Area #3 is an area of suspect moisture infiltration.

Core Samples should be taken to confirm the presence of moisture.

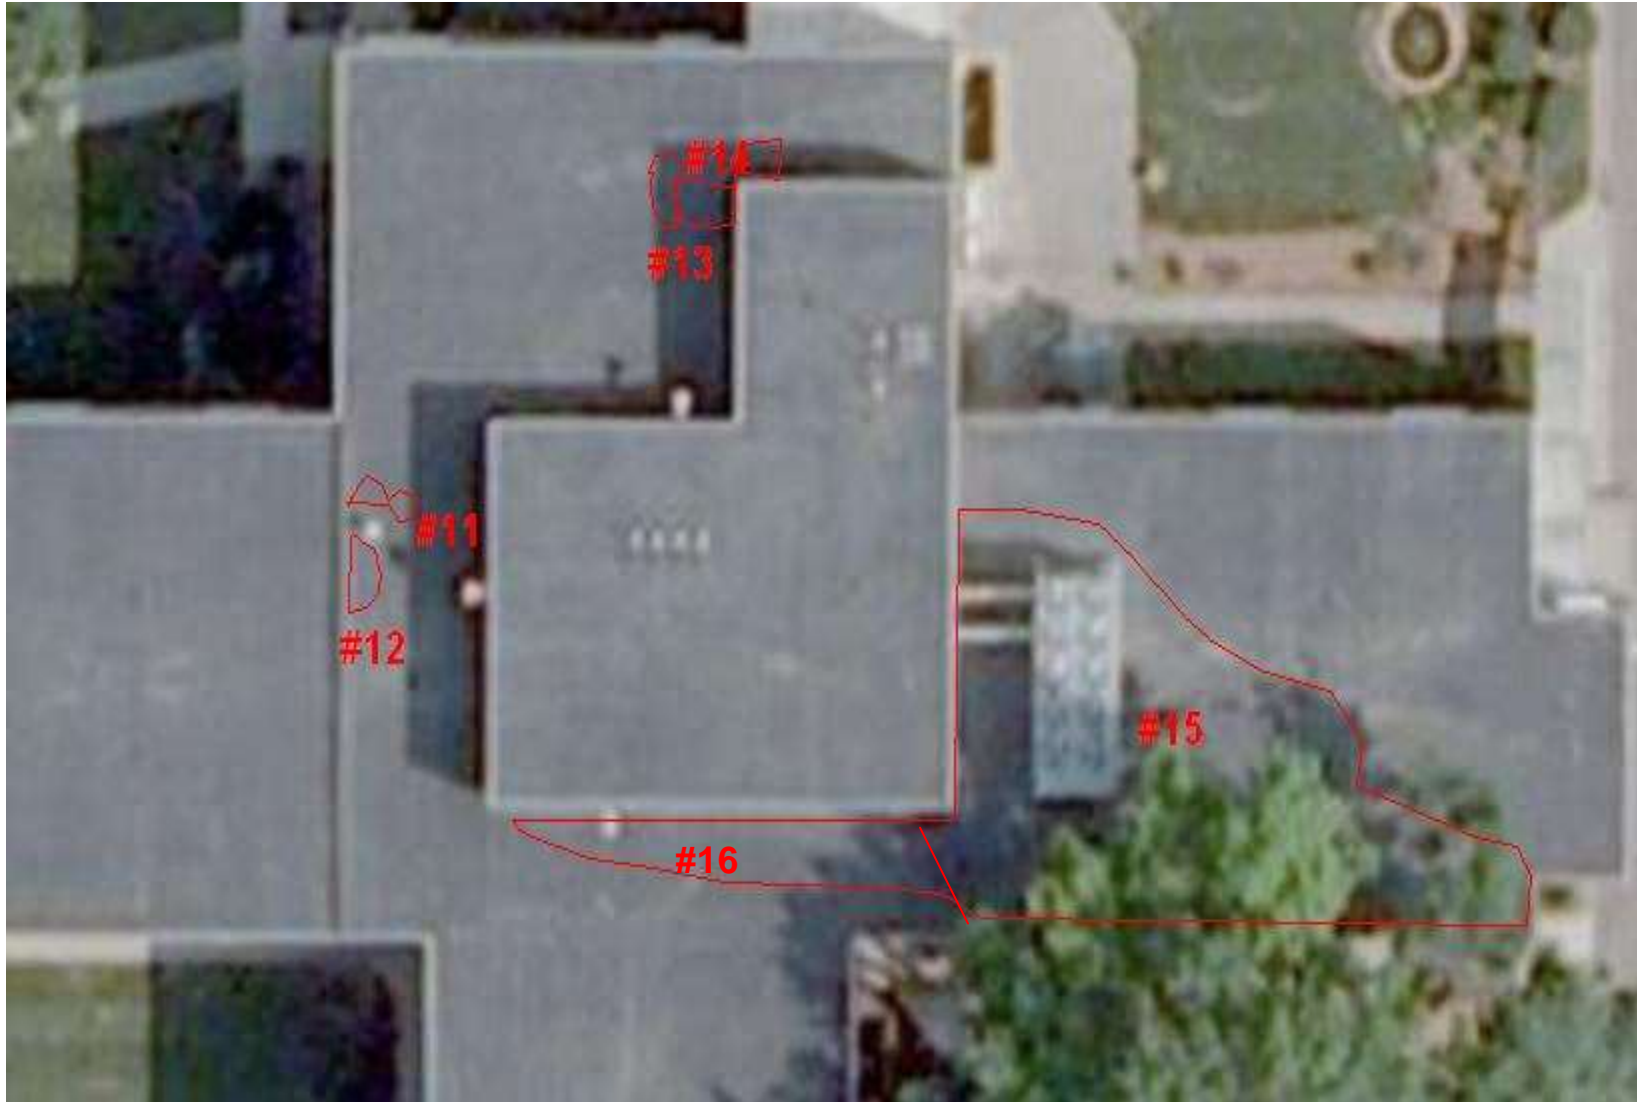
Area: Approximate Outline of Areas #11-16

Notes: Multiple areas shown on the Alzheimer's Building. The outline of #15 shows the entire area of concern as well as areas #11-16. Core samples should be taken in different locations within these areas to confirm the presence of moisture.

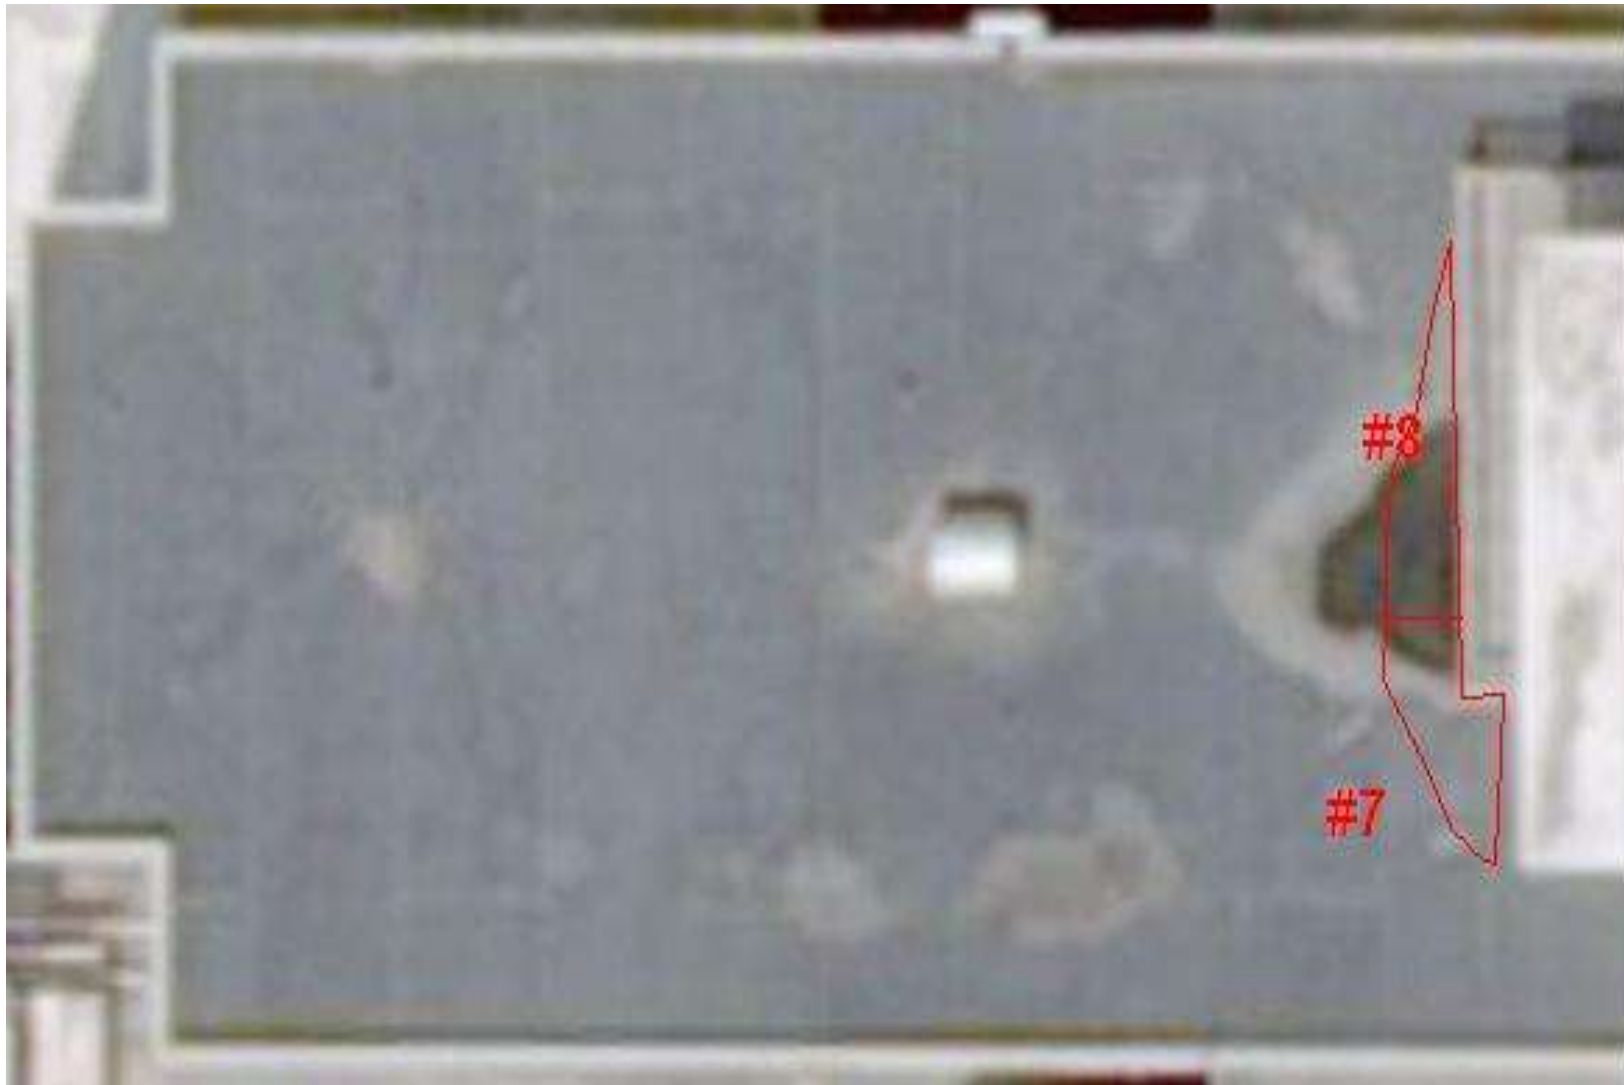
Area: Approximate Outline of Areas #7 & #8

Notes: The moisture infiltration seems to show that it “bleeds” out to these areas but is concentrated under the deck area. Core samples should be taken in different locations within these areas to confirm the presence of moisture.
