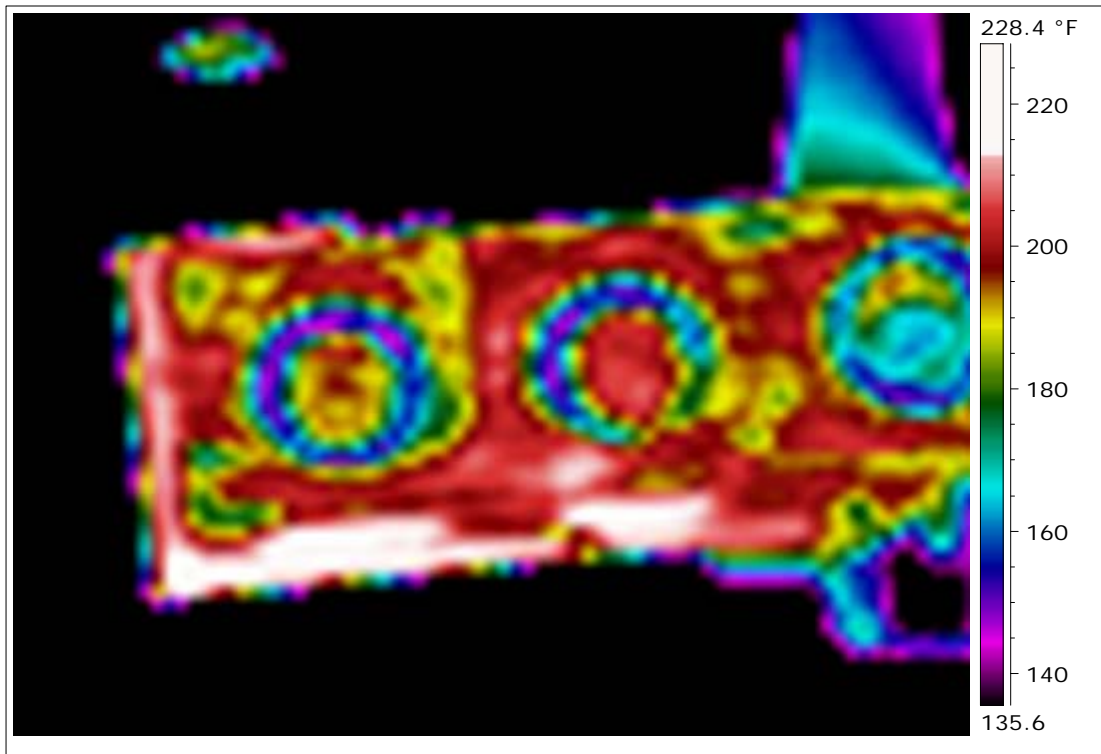
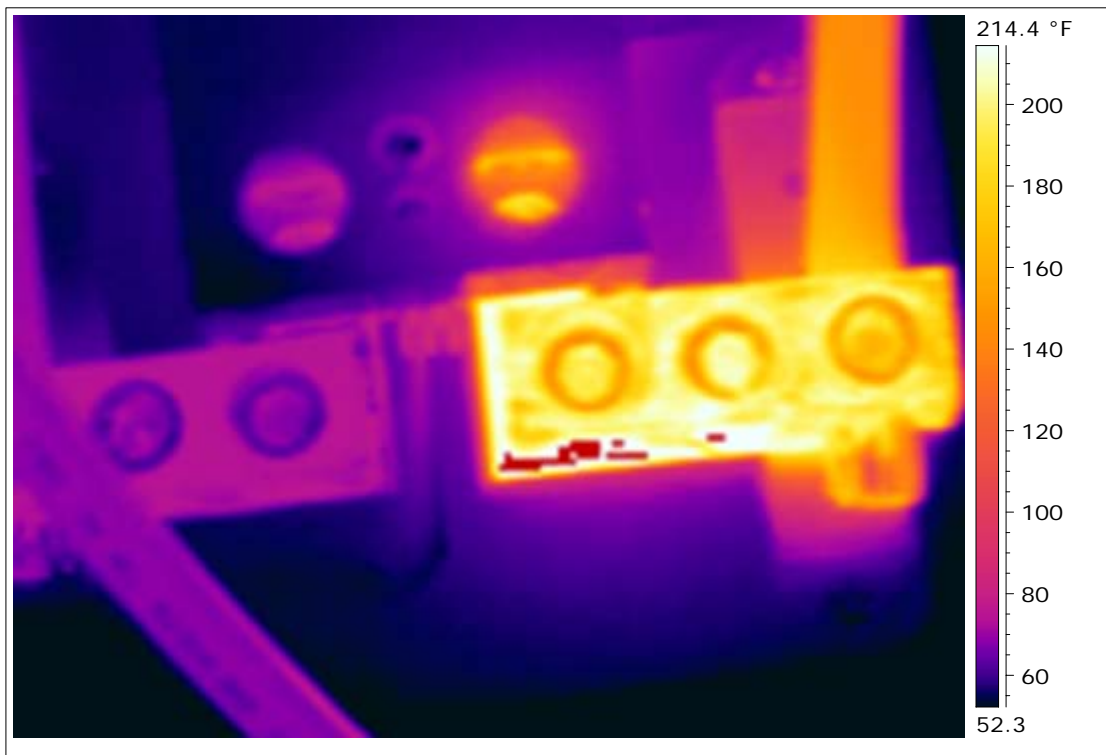
I am assuming that what is here is a “lug” on top of the bus stab. The image on the top shows the image zoomed in and the thermal focus tightened. This shows what appears to be the lower bus stab is hotter. This is likely where the source of the looseness is. Special care should be taken though to also inspect the bus area behind panel shows heating too. This is a very good image for the camera that you have. The bottom image also shows the area that has gone over range for this camera. Not knowing the material time we can not adjust the Emissivity but even so we have already topped out the camera temperature range. There is a potential here to have a connection that could exceed 300 or 400 degrees F. It was very good thinking to put the maximum load possible on the system to bring out the severity of the problem. I would recommend that you also check the amp load as even if you brought the load up to 150amp you are only at 75% FLA and the heating could even exceed 500+. Good find and more importantly GREAT job using your skills to take it the extra needed. This one is a potential life saver.
