Thermography Report

Customer: BSI Property
Address: Lincoln, NE

Thermography date: March 2009
Thermographer: OJ Utter

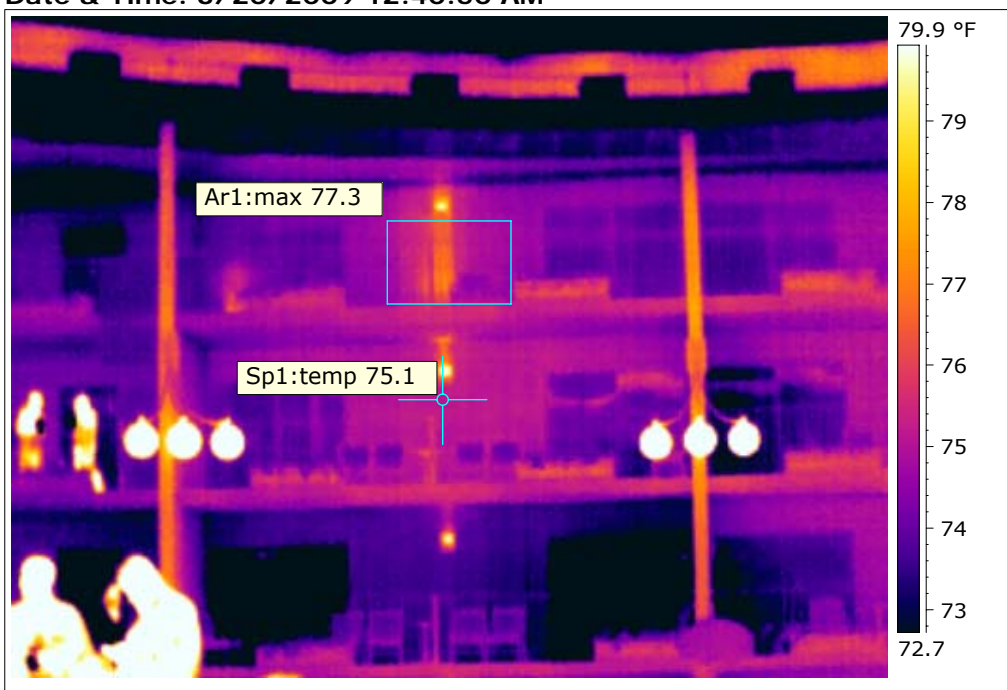
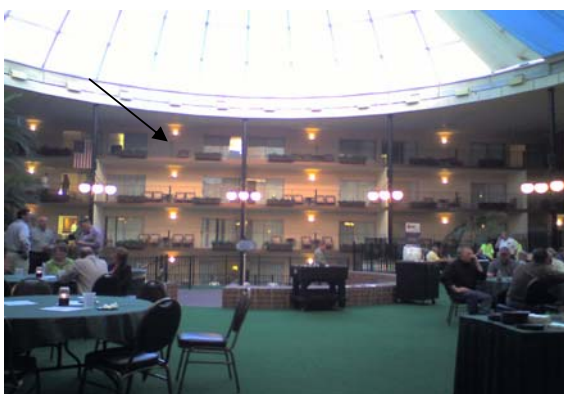
Captured at: Main Dome Area

Heating behind the wall shown on the 4th floor between room 321 and 323.

Inspect the light fixture on that floor for loose connections.

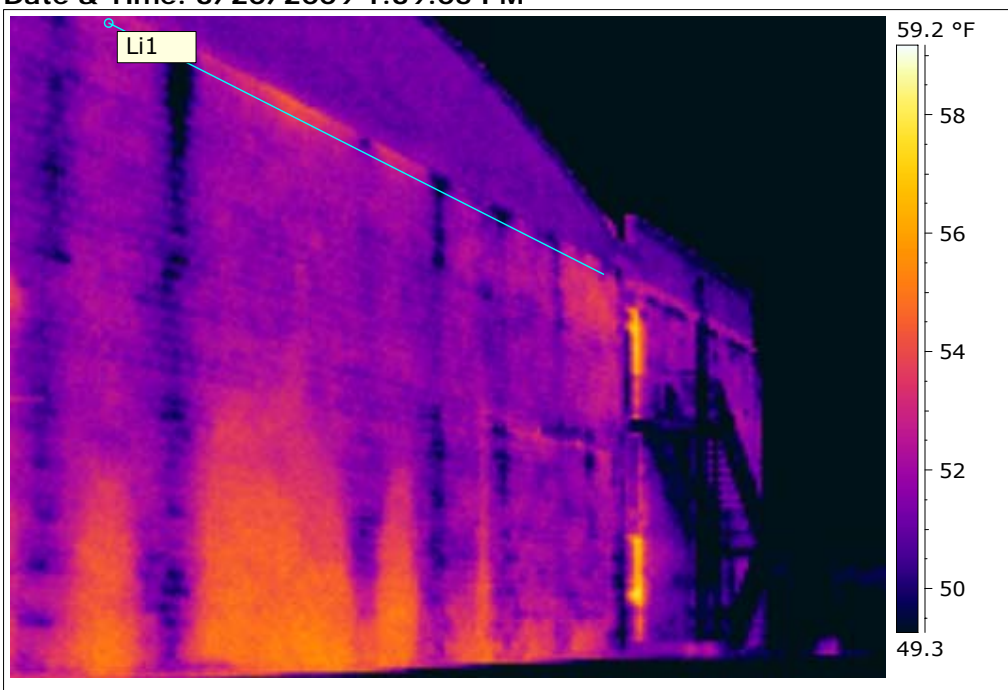
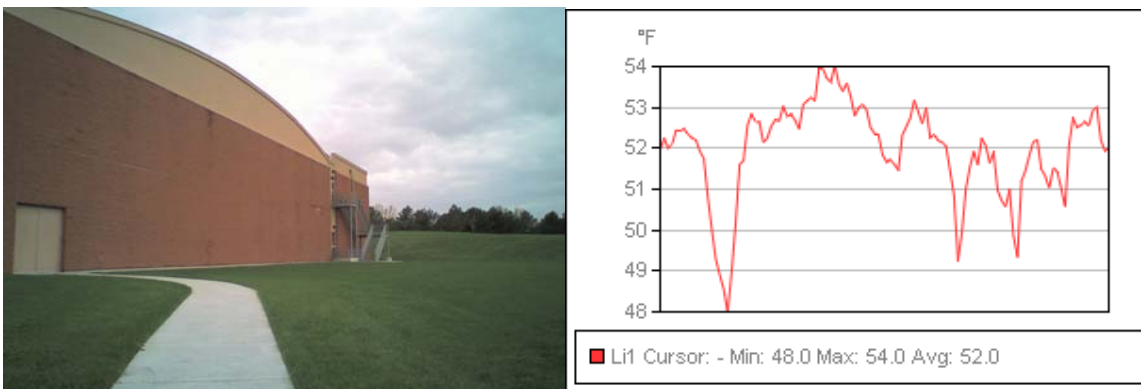
Captured at: West Side of Building- Outside

Area outside the pool shows leaks are present

Clean and Reseal as appropriate. Inspect for development of possible mold issue
