Infrared Inspections

Thermography Inspection at

Manufacturing Plant

10/1-2/2007

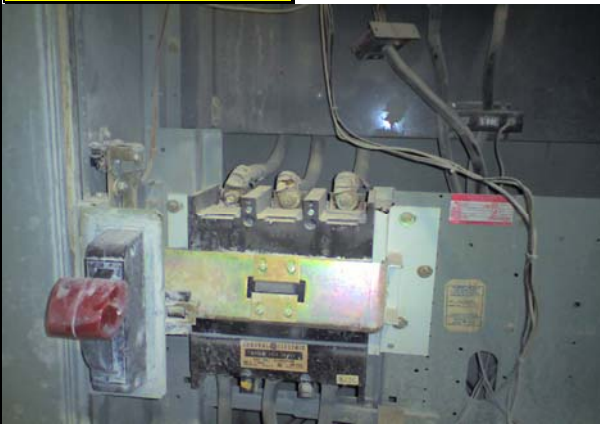
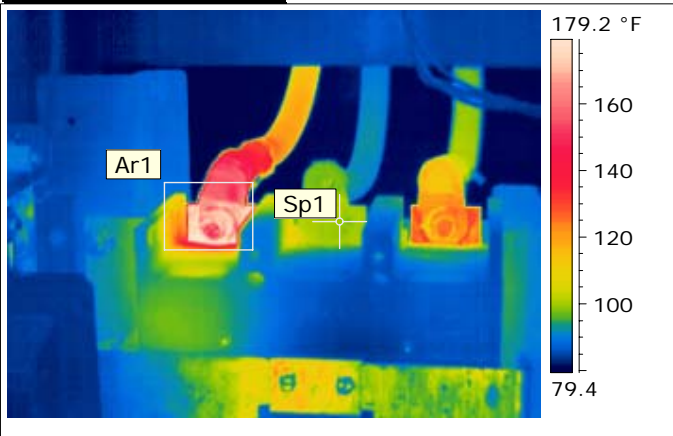
Photo and Identification

Location	South Raymond Mill MCC
Equipment	South Raymond Mill Main Breaker
Component	A Phase Line
Priority Level	IMMEDIATE ATTENTION
Reocmmendations	85
Amperage Load	400amp
Average Load	A-123 B-130 C-126
Recommendation	splc1
Notes

Object Parameters	Value
Atmospheric Temperature	70.8 °F
Emissivity	0.90
Sp1 Temperature	99.2 °F
Ar1 Max. Temperature	181.0 °F

Heating of the connection is of such a high concern because of the temperature at load amperage rating and the fact that the heating is on the Line and Load side of the breaker indicates that the breaker could be failing. Tighten the connections within the week and inspect again with Infrared. If the heating continue check the load again and have testing performed on the breaker at the next available opportunity
