Remote Vibration Analysis

Remote Analysis Capabilities

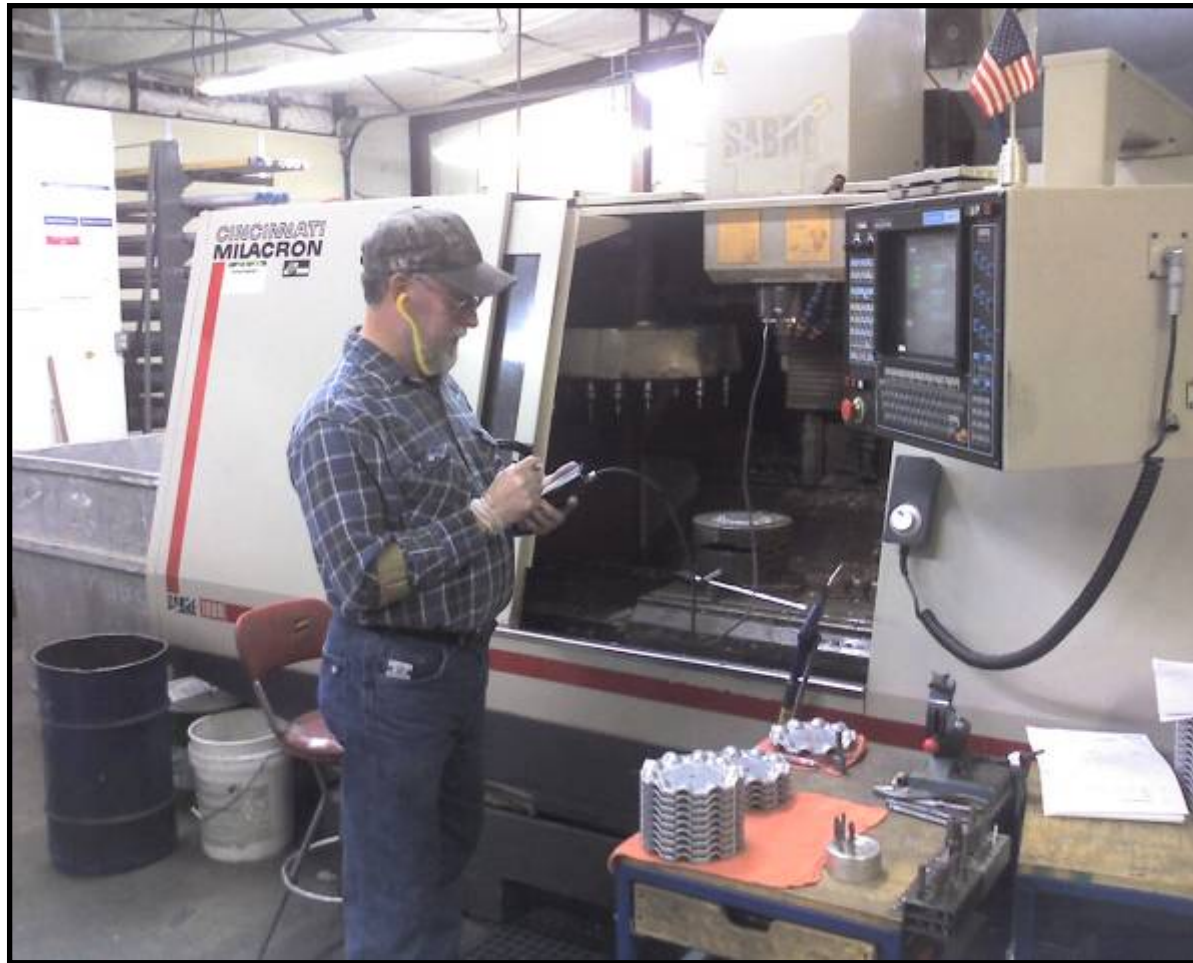
Machine Operator Taking Data

The Machine operator with minimal training was able to take readings.

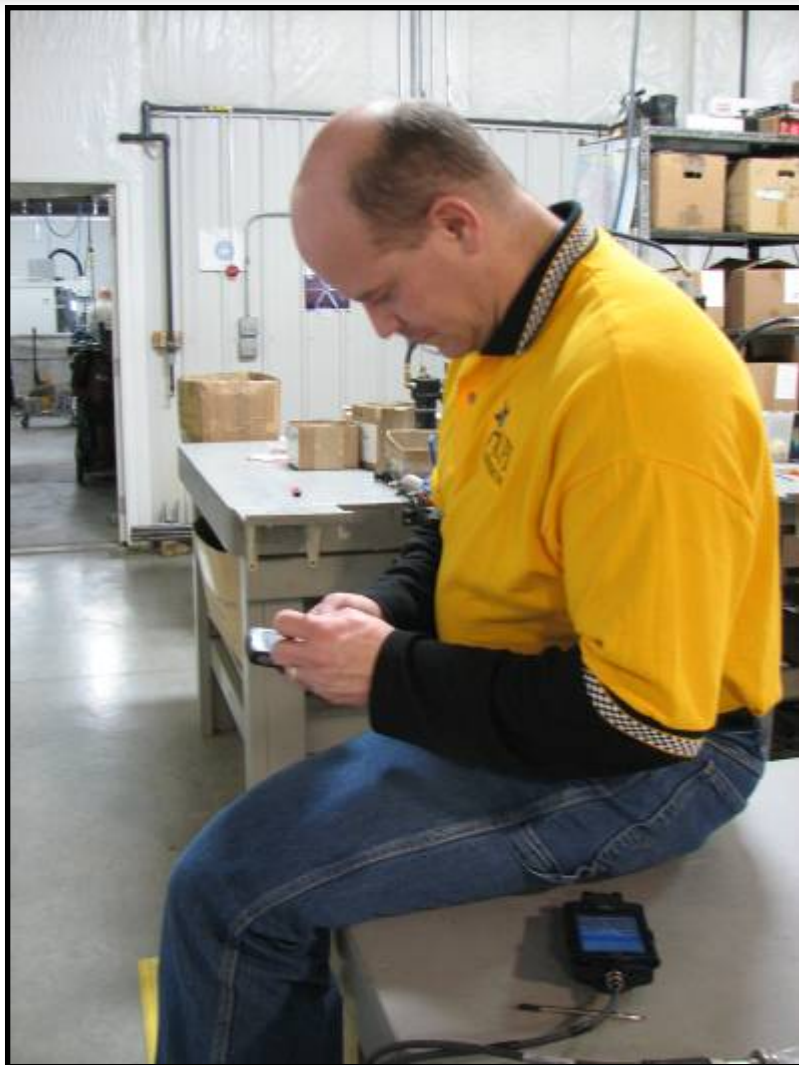
Me Analyzing the Data Elsewhere

Using the SiteConnex™ software on my Palm Treo, I received the Data and was able to analyze the condition of the bearing on both the spindle and the motor driving the CNC machine.

I then took a screen shot showing the issue and attached that to a return email stating the condition and giving repair recommendations so that a timely repair could be performed before the equipment failed.

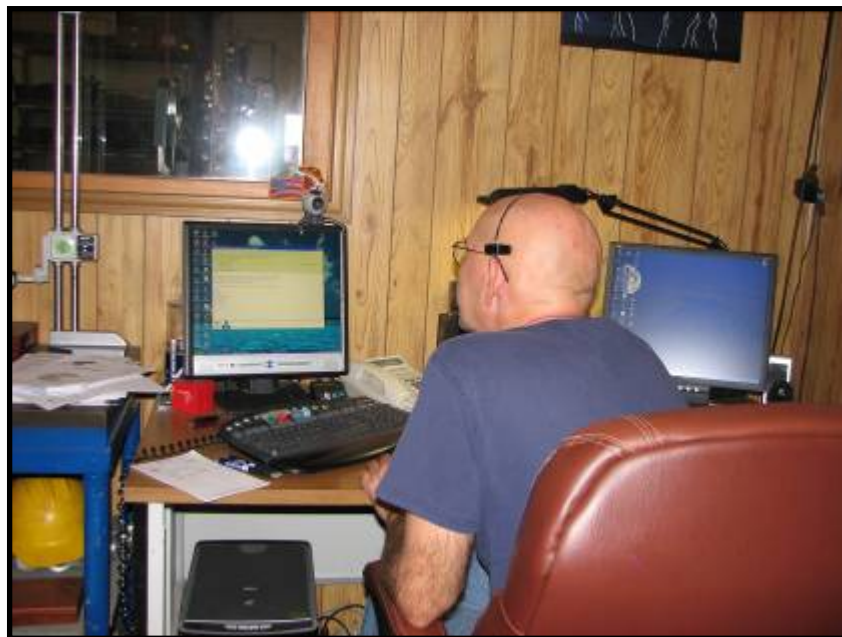
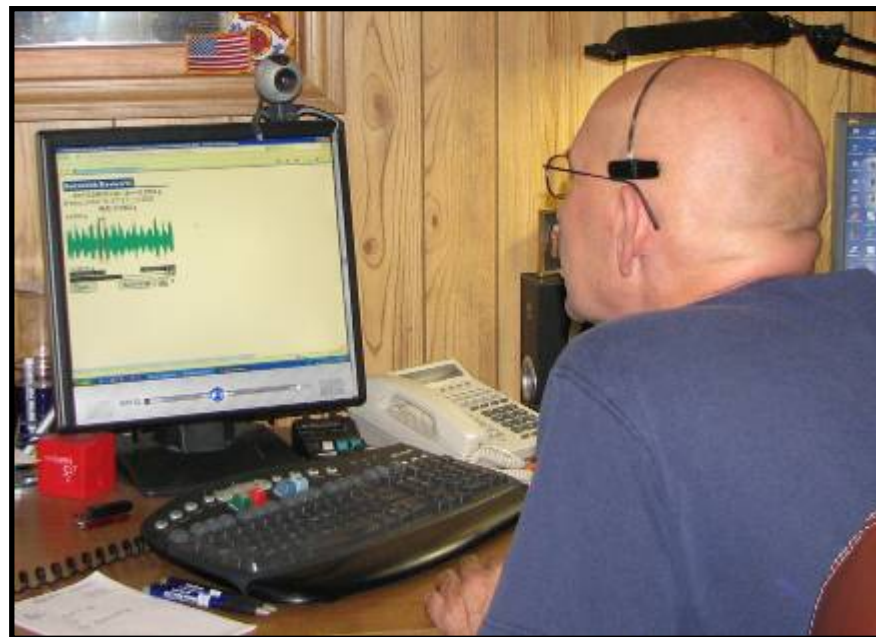
Owner Reviewing Emailed Analysis

The owner of the company received my email back in less than 15 minutes from sending it to me and was able to not only read my recommendations but also see the facts by viewing the screen shots.
